THOSE DAMN ZENITH STROMBERGS

*By John H. Twist
of University Motors*

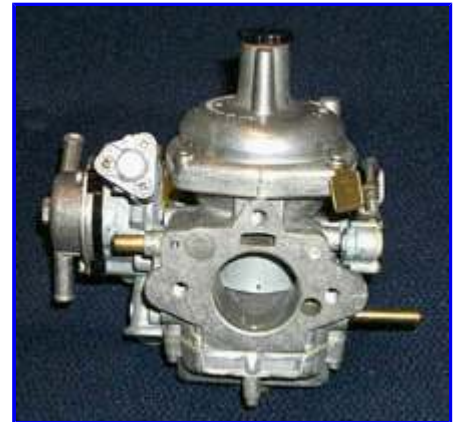
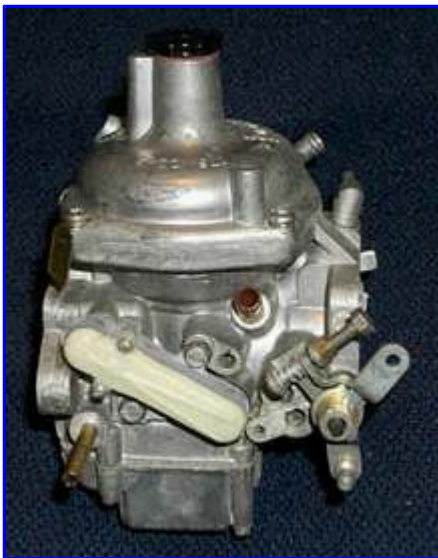
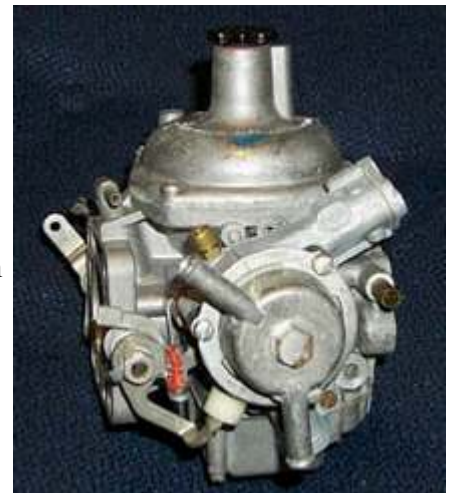
The carb illustrated is a
slightly modified version from
that of the MGB, but will give
you a good idea of how things
are put together.
